**Nr.: 36/09.05.2017**

## **Evaluation report**

**„Degenfeld-Schomburg” Castle Balc Facility , Bihor county, Romania.**

**Date:**  
**May 2017**

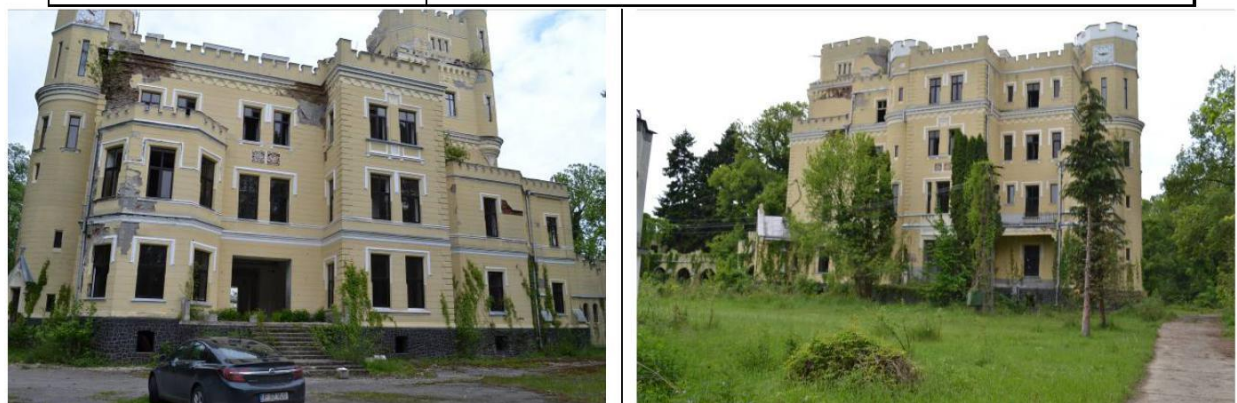
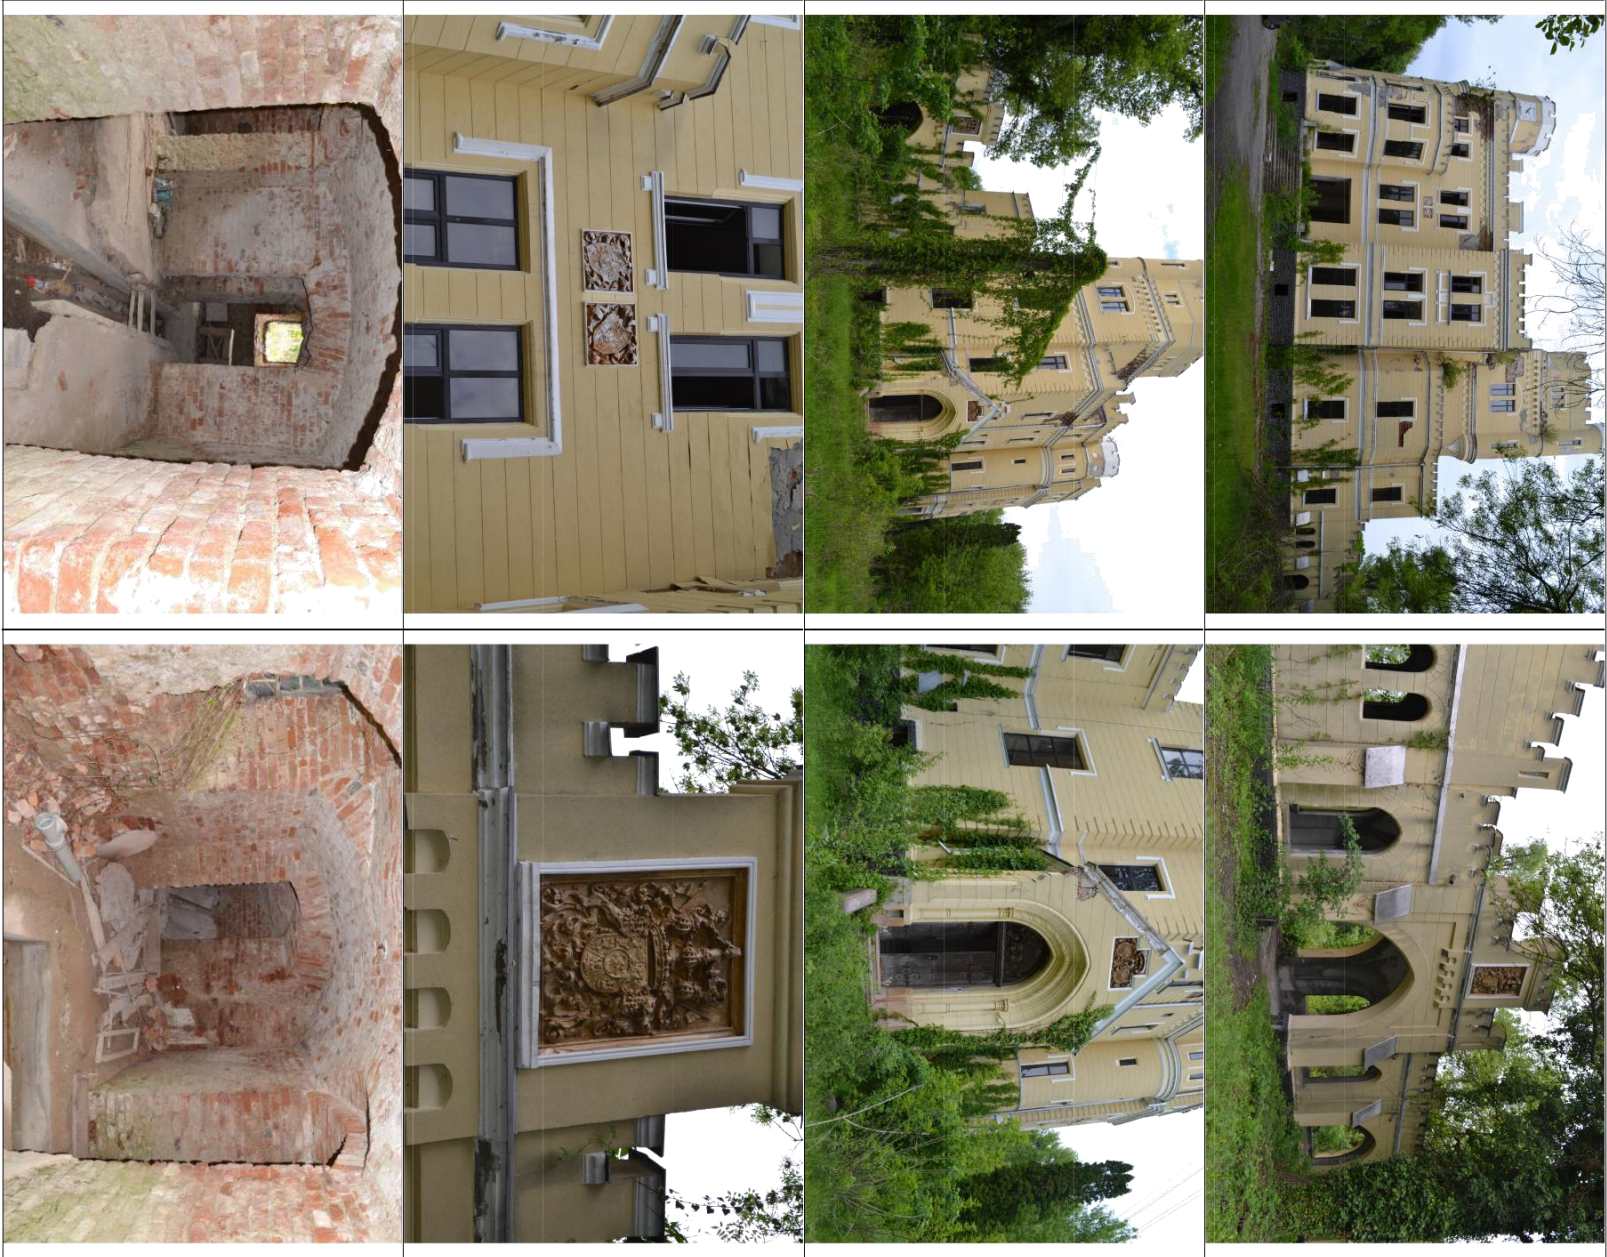
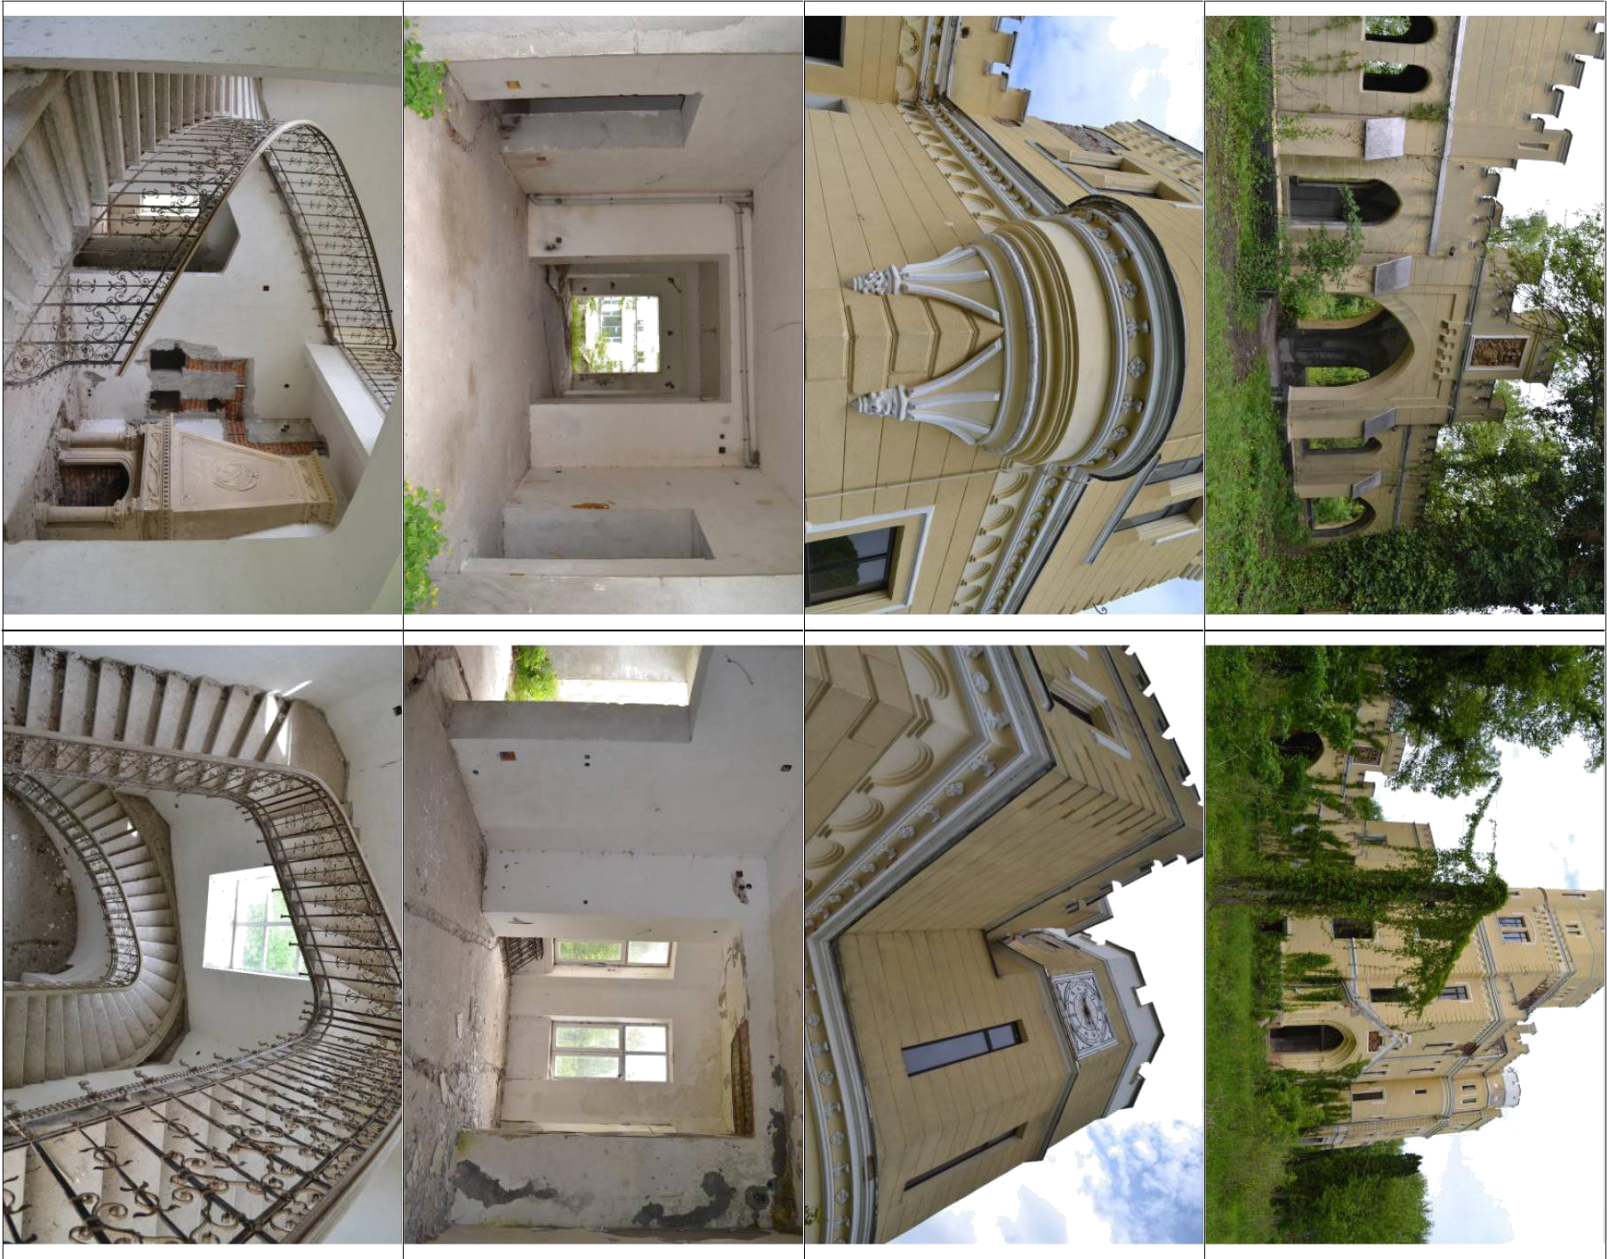
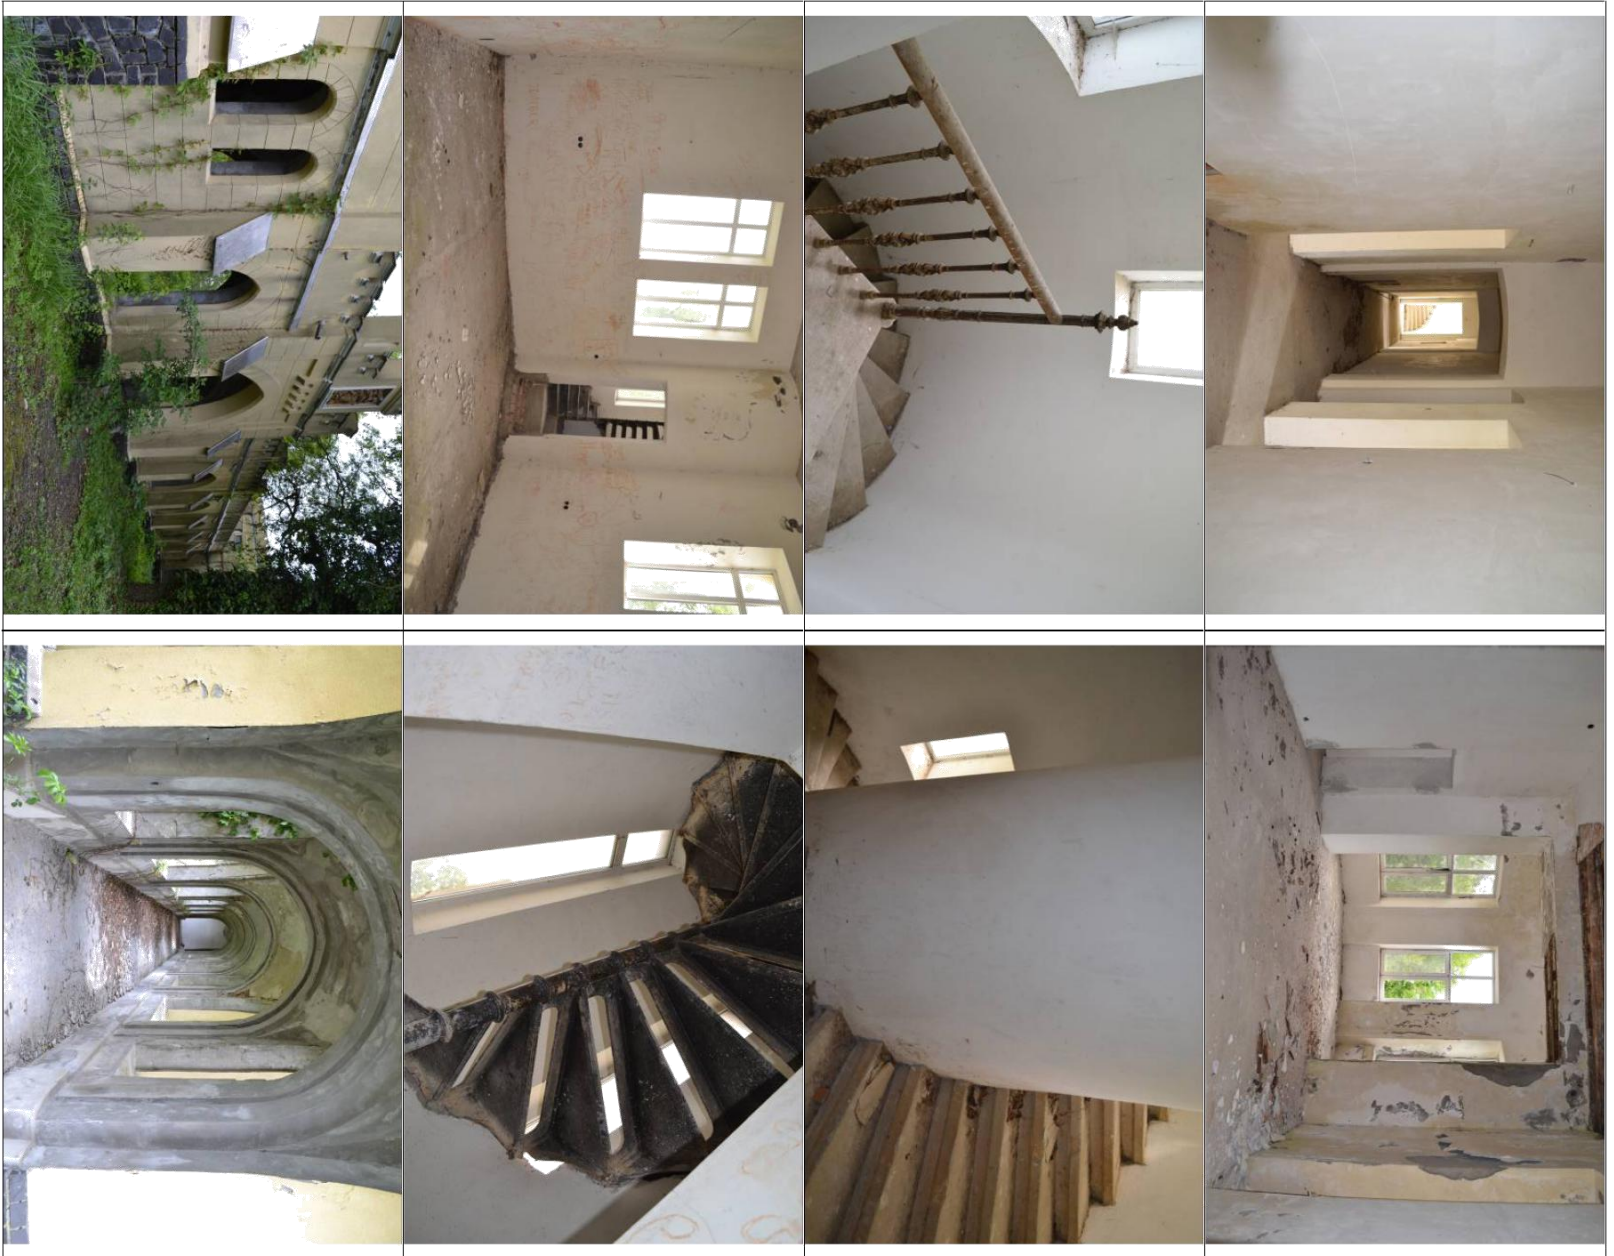
Sheet 1	
Position on the location plan	C1
Subject	Castle Part A
Owner	S.C. A.D.L. INVEST Ltd.
PIF date	1889/2000
Structural description	
Height category	S+P+4E (basement+groundfloor+ 4 floors)
Average H	3,9 m
Area built on the ground	518 msq
Unfolded built area	2375 msq
Basis	Brick
Structure and partitioning	Brick
Floor	Wood
Pavement	Concrete leveling layer
Roof	Type terrace water insulation covered with zinc coated tin
Exterior finishings	Concrete covering, separations and margins, plain whitewashing; stone basis, PVC external framing with double glazed windows
Interior finishings	Wall concrete covering, partially plastered, concrete flooring
Installations	No installations Broken roof, rain water infiltrations; Broken external wall covering. the building is in a good condition. renovation work was done but not finished. No power, sewage and thermal installations.
Technical conditions

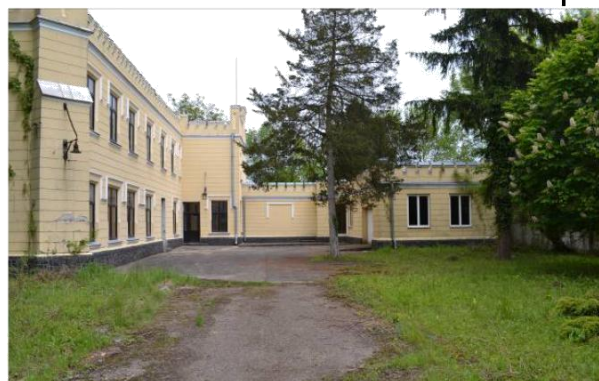
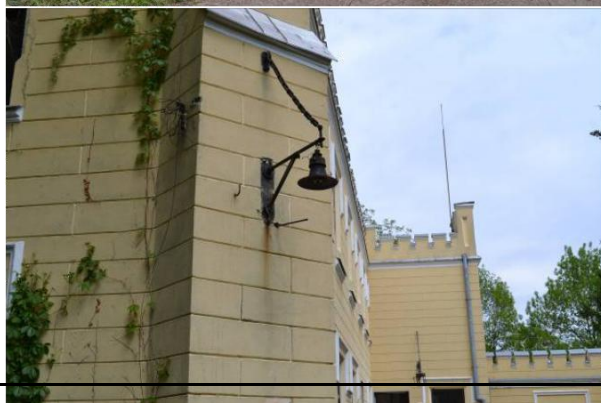
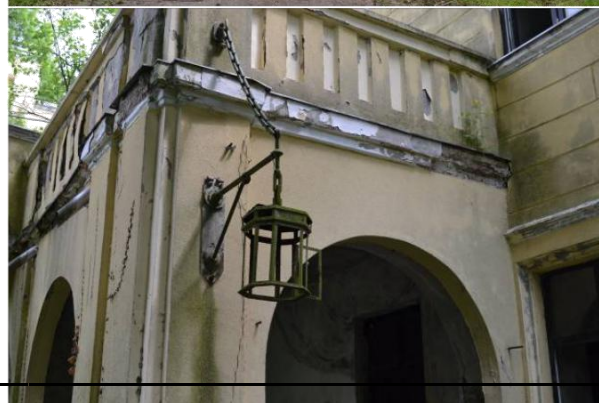
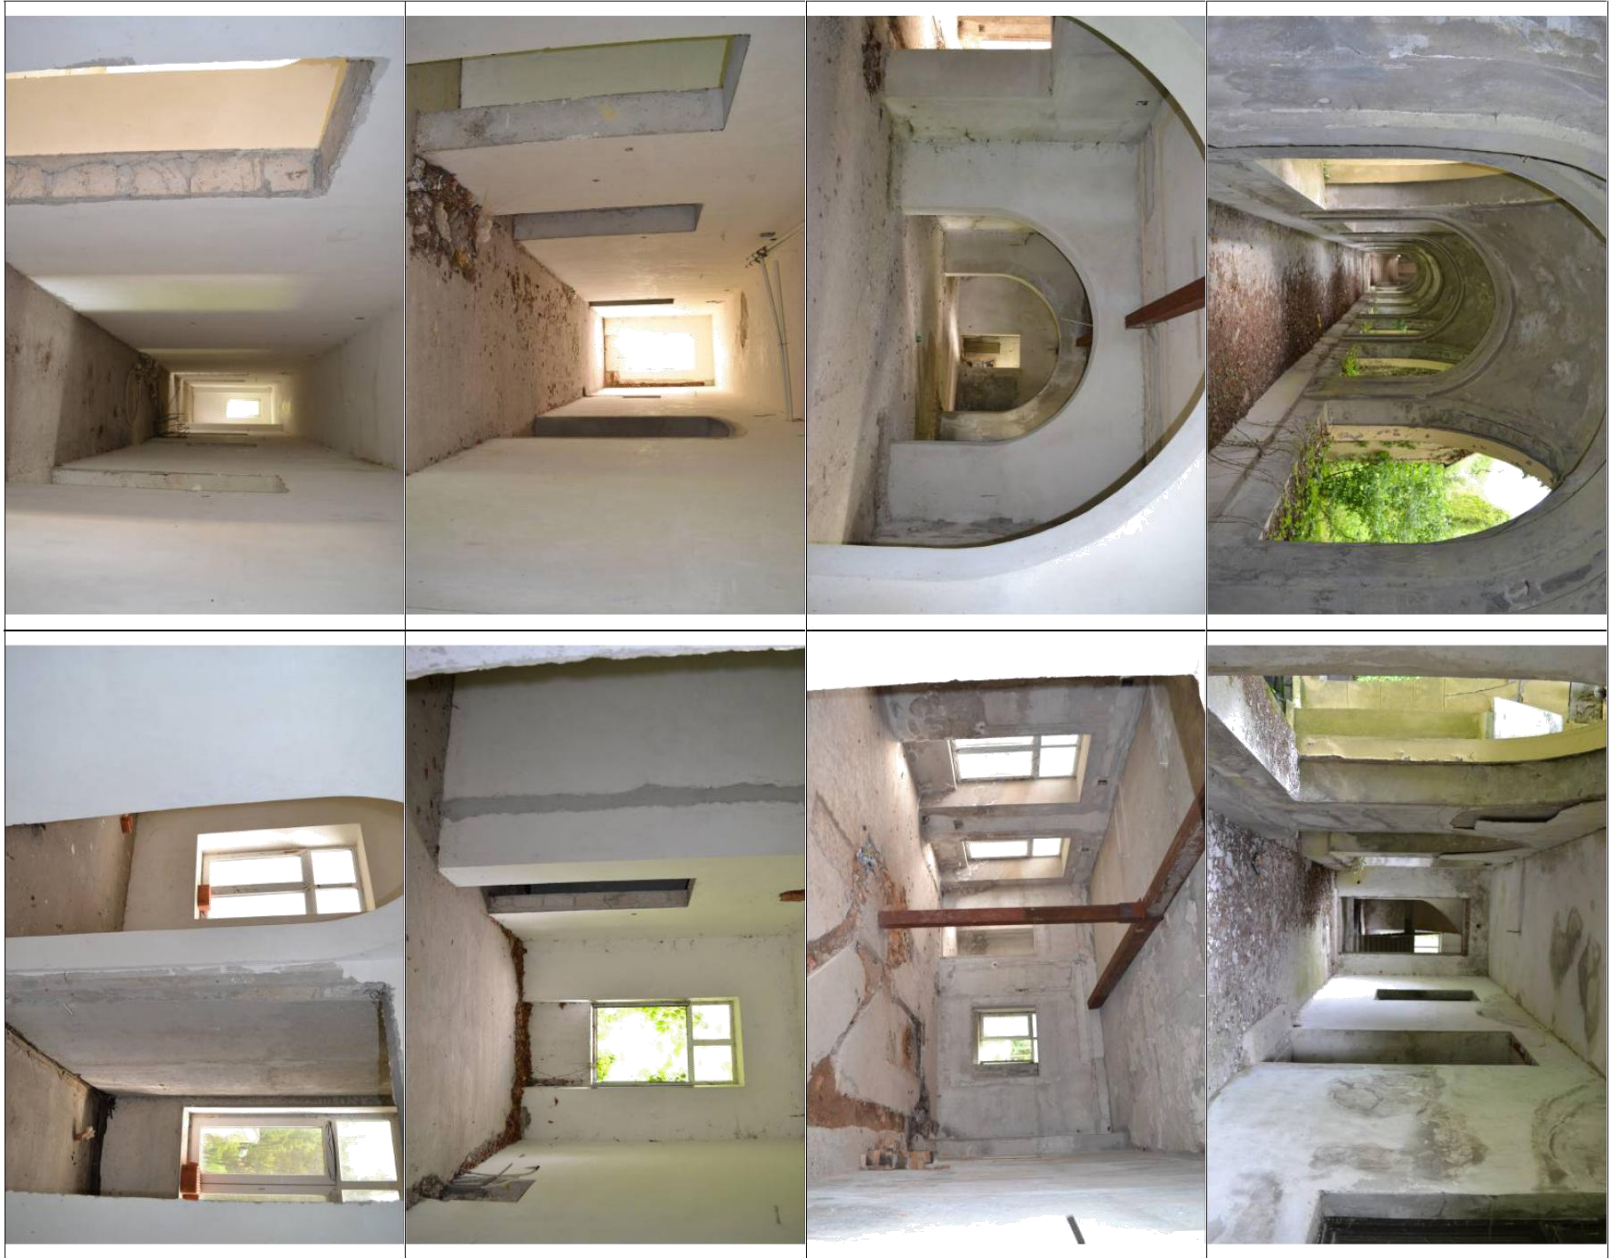
Sheet 2		
Position on the situation plan	C2	
Subject	Castle Part B	
Owner	S.C. A.D.L. INVEST Ltd.	
PIF date	1889/2000	
Structural description		
Height level	P+1E	
Average H	3,4 m	
Area built on the ground	579	
Unfolded built area	1029	
Basis	Brick	
Structure and partition	Brick walls	
Floors	Brick arches on the basement and wooden arches over the groundfloor and floors	
Floors	Concrete layer	
Roof	Type terrace water insulation covered with galvanized tin	
External finishings	Neat Plaster imitation of relief, separations and margins, plain whitewashing;	
indoor finishings	Basis of appearing stone, PVC external framing with double glazed windows Neat plaster covering, indoor wooden framing	
Installations	Channels into the walls and floors for the position of sewage and heating installations.	
Technical conditions	Pipes for the positioning of the power installations were found. The structure of the building is in good condition. The roof has some damages and as a result there are rain water infiltration in some places. in diverse locuri. The finishings are at the level of half finished. The installations need replacement.

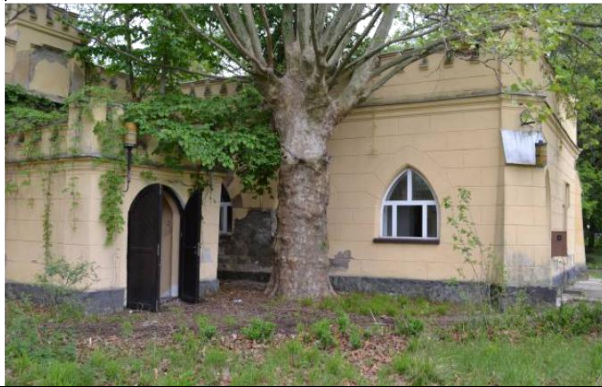
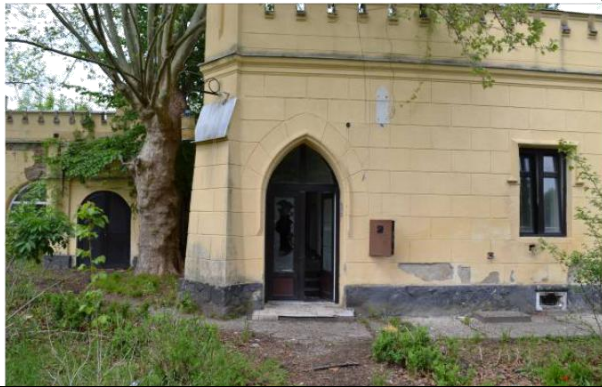
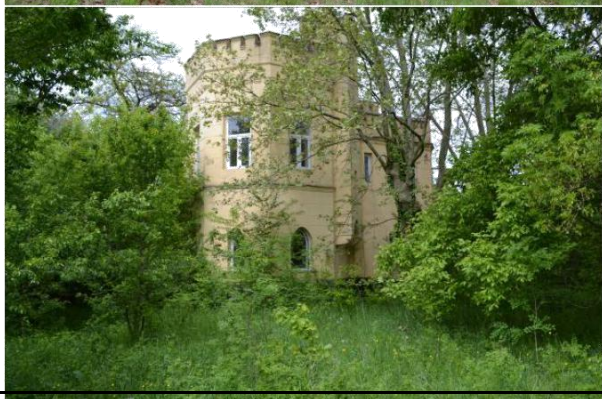
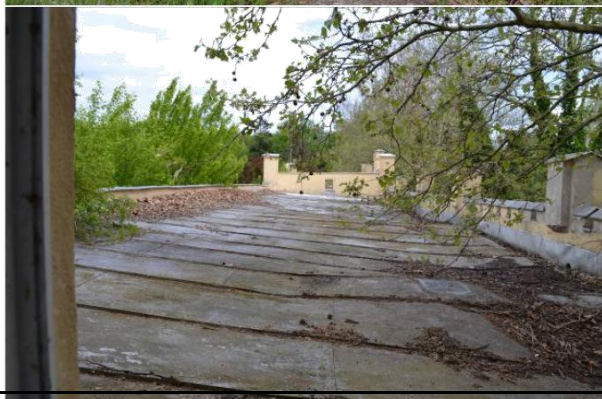
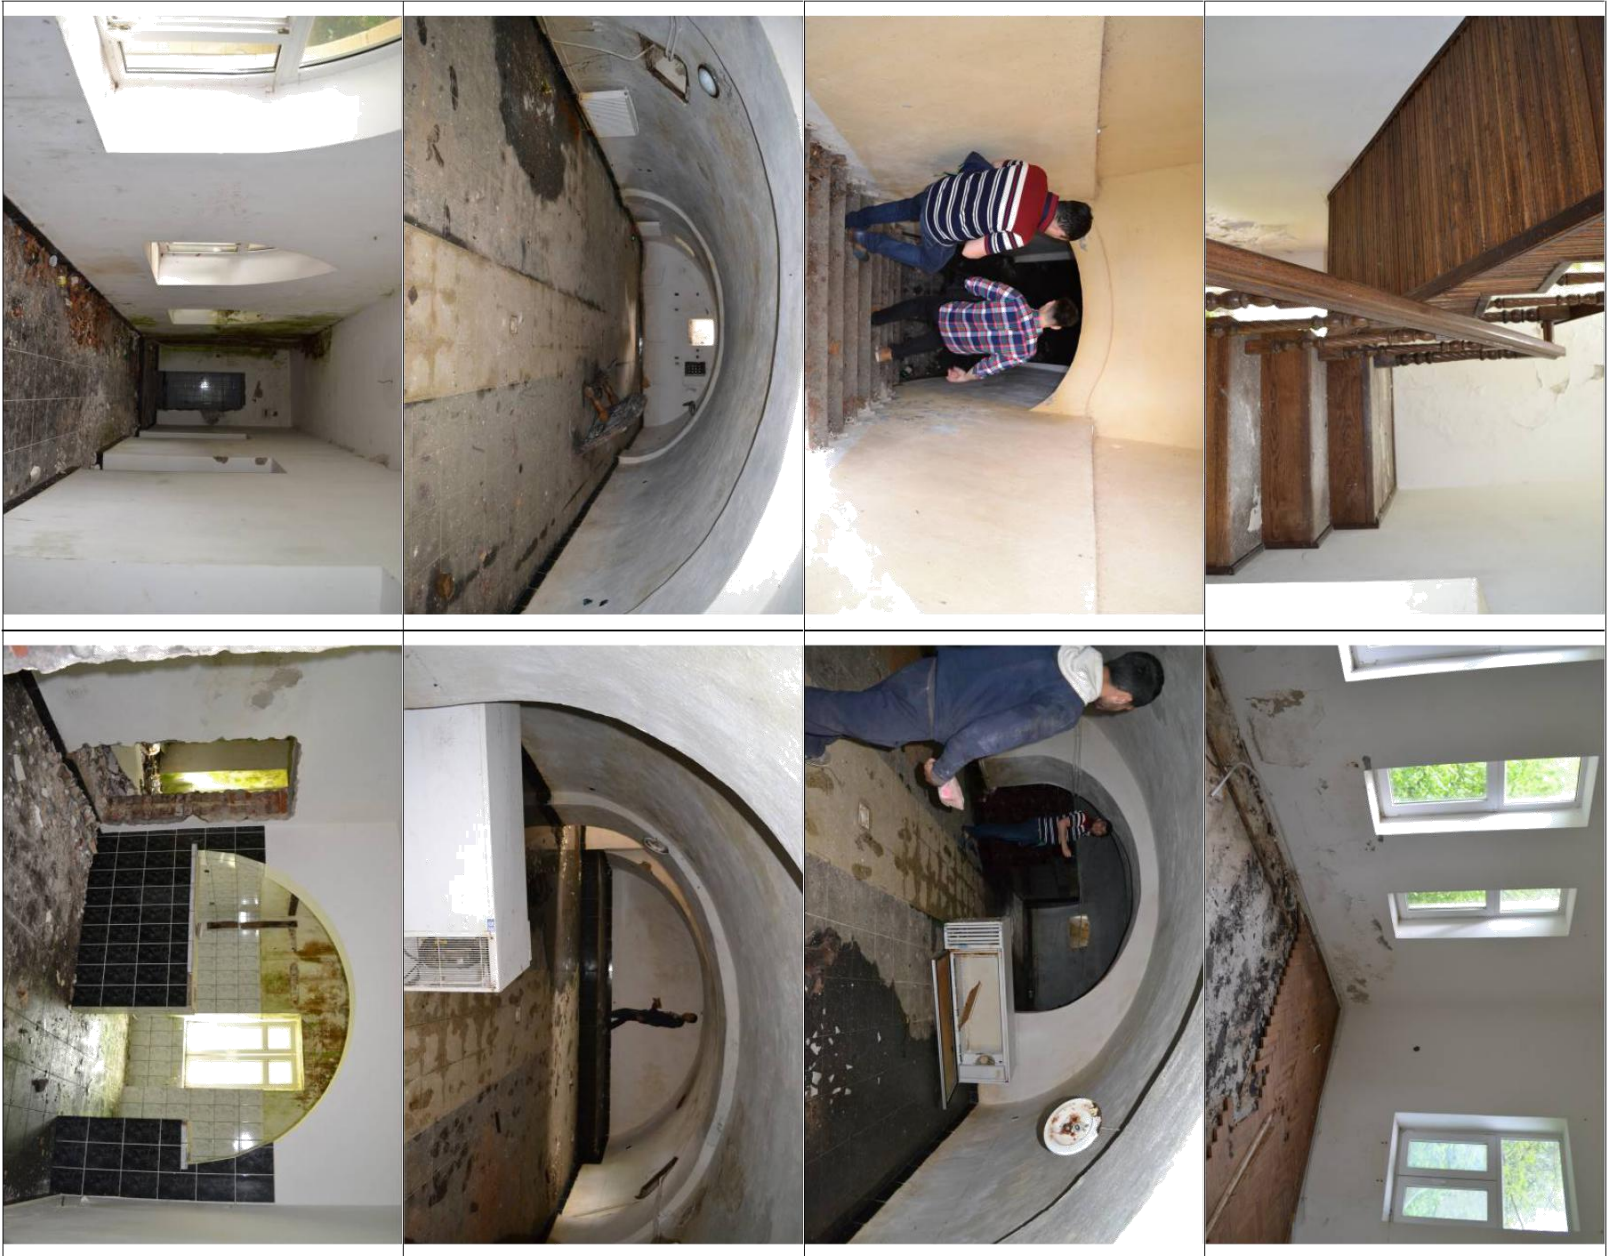
Sheet 3	
Position on the situation plan	C3
Subject	Castle part C
Proprietar	S.C. A.D.L. INVEST Ltd.
PIF date	1890/2000
Structural decsription	
Height level	S+P+1E
Average H	2,5 m
Area built on the ground	950
Unfolded built area	1186
Basis	Din caramida
Structure and partition	Brick walls
Floors	Brick arches over the basement and wooden arches over the groundfloor
Pavement	Ceramic tiles in the hallways, kitchen, old parquet (swollen) in some rooms, concrete layers and
Roof	Type water proof insulation covered with galvanized tin
External finishings	Plaster layer imitation of reliefs. separations and margins, plain whitewashing, Basis of apparent stone, external PVC framing, with double glazed windows
Indoor finishings	Neat plastering and whitewashing, wooden indoor framing
Installations	Power, sewage and heating installations not functional.
Technical conditions	The structure of the building is in good condition. There are some damages of the roof that led to rain water infiltration in some places. The finishing and the installations need to be redone.

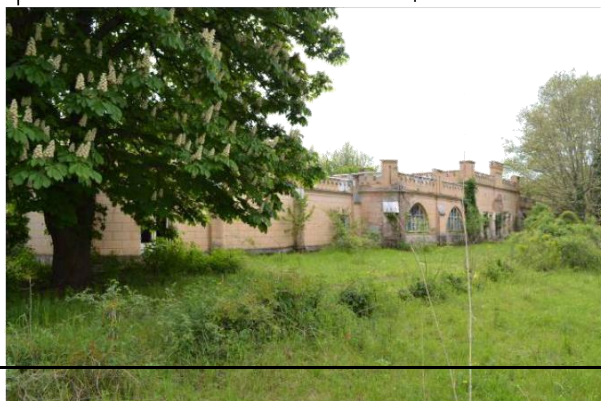
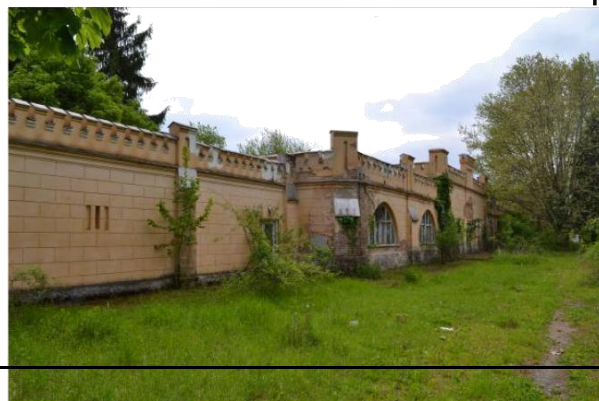
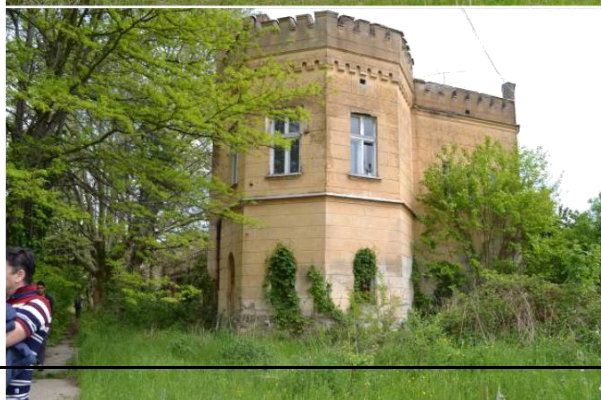
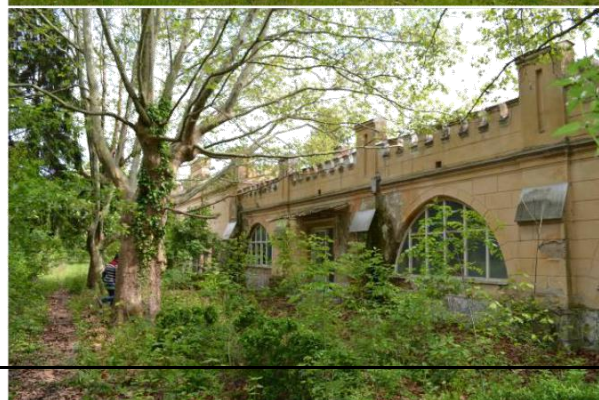
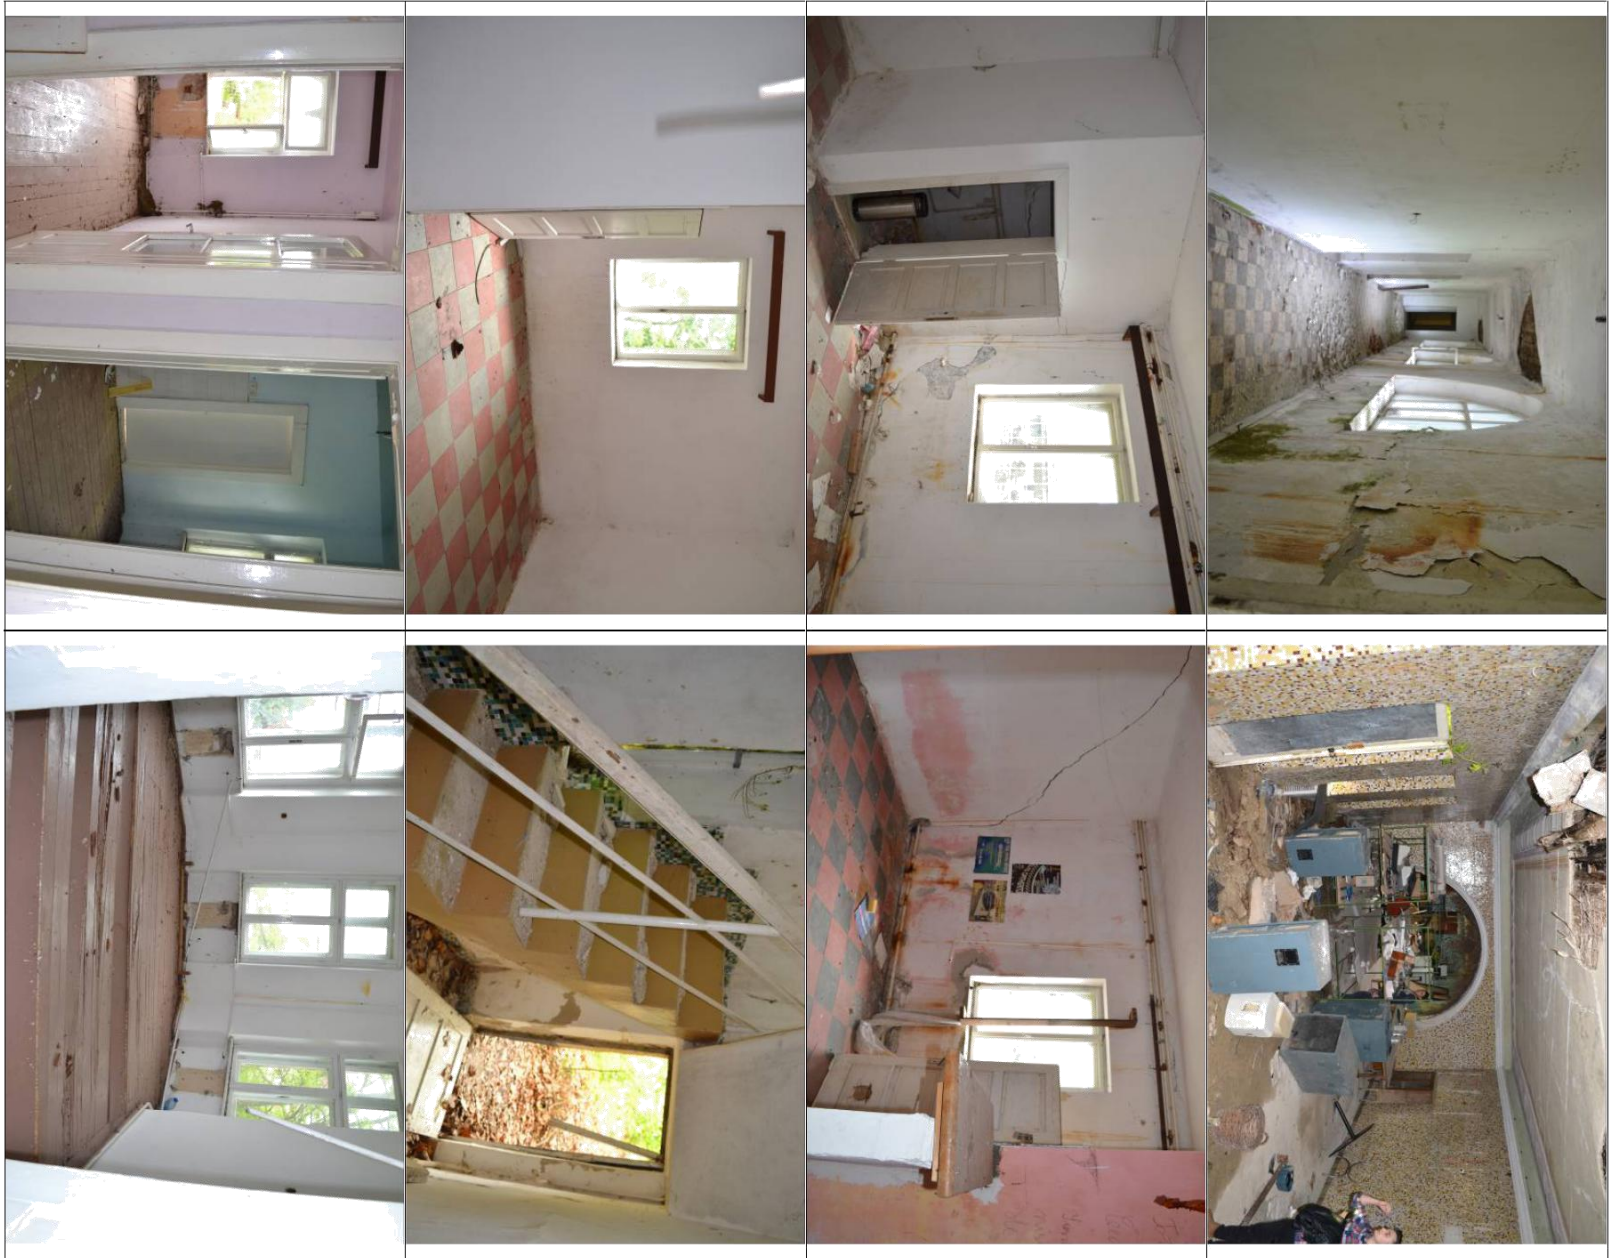
<b>Sheet 4</b>	
<b>Position on the situation plan</b>	<b>C4</b>
<b>Subject</b>	<b>Castle Part D</b>
<b>Owner</b>	<b>S.C. A.D.L. INVEST Ltd.</b>
<b>PIF data</b>	<b>1890</b>
<b>Structural description</b>	
<b>Height level</b>	<b>P+1E</b>
<b>Average h</b>	<b>3,5 m</b>
<b>Area built on the ground</b>	<b>634</b>
<b>Unfolded built area</b>	<b>724</b>
<b>Basis</b>	<b>Brick</b>
<b>Structure and partition</b>	<b>Brick walls</b>
<b>Floors</b>	<b>wooden</b>
<b>Pavement</b>	<b>Ceramic tiles in the hallways, bathrooms, kitchen (partially deformed) and wooden flooring in the rooms in a bad condition</b>
<b>Roof</b>	<b>Type water proof insulation covered with the galvanized tin</b>
<b>External Finishings</b>	<b>Plaster layer imitation of reliefs. separations and margins, plain whitewashing, basis of apparent stone, wooden indoor framing</b>
<b>Indoor finishing</b>	<b>Neat plastering and whitewashing, wooden indoor framing</b>

<b>Dotari instalatii</b>	<b>Power, sewage and heating installations not functional.</b>
<b>Stare tehnica</b>	<b>The structure of the building is in good condition. There are some damages of the roof that led to rain water infiltration in some places. The indoor finishing and the installation need replacement.</b>

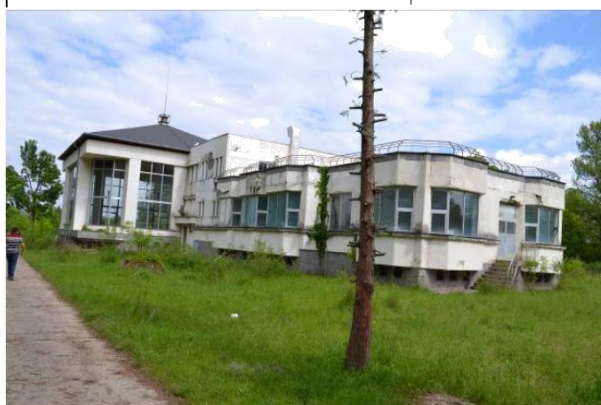
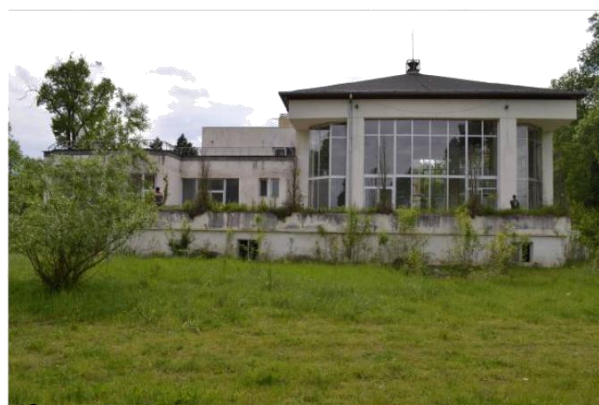
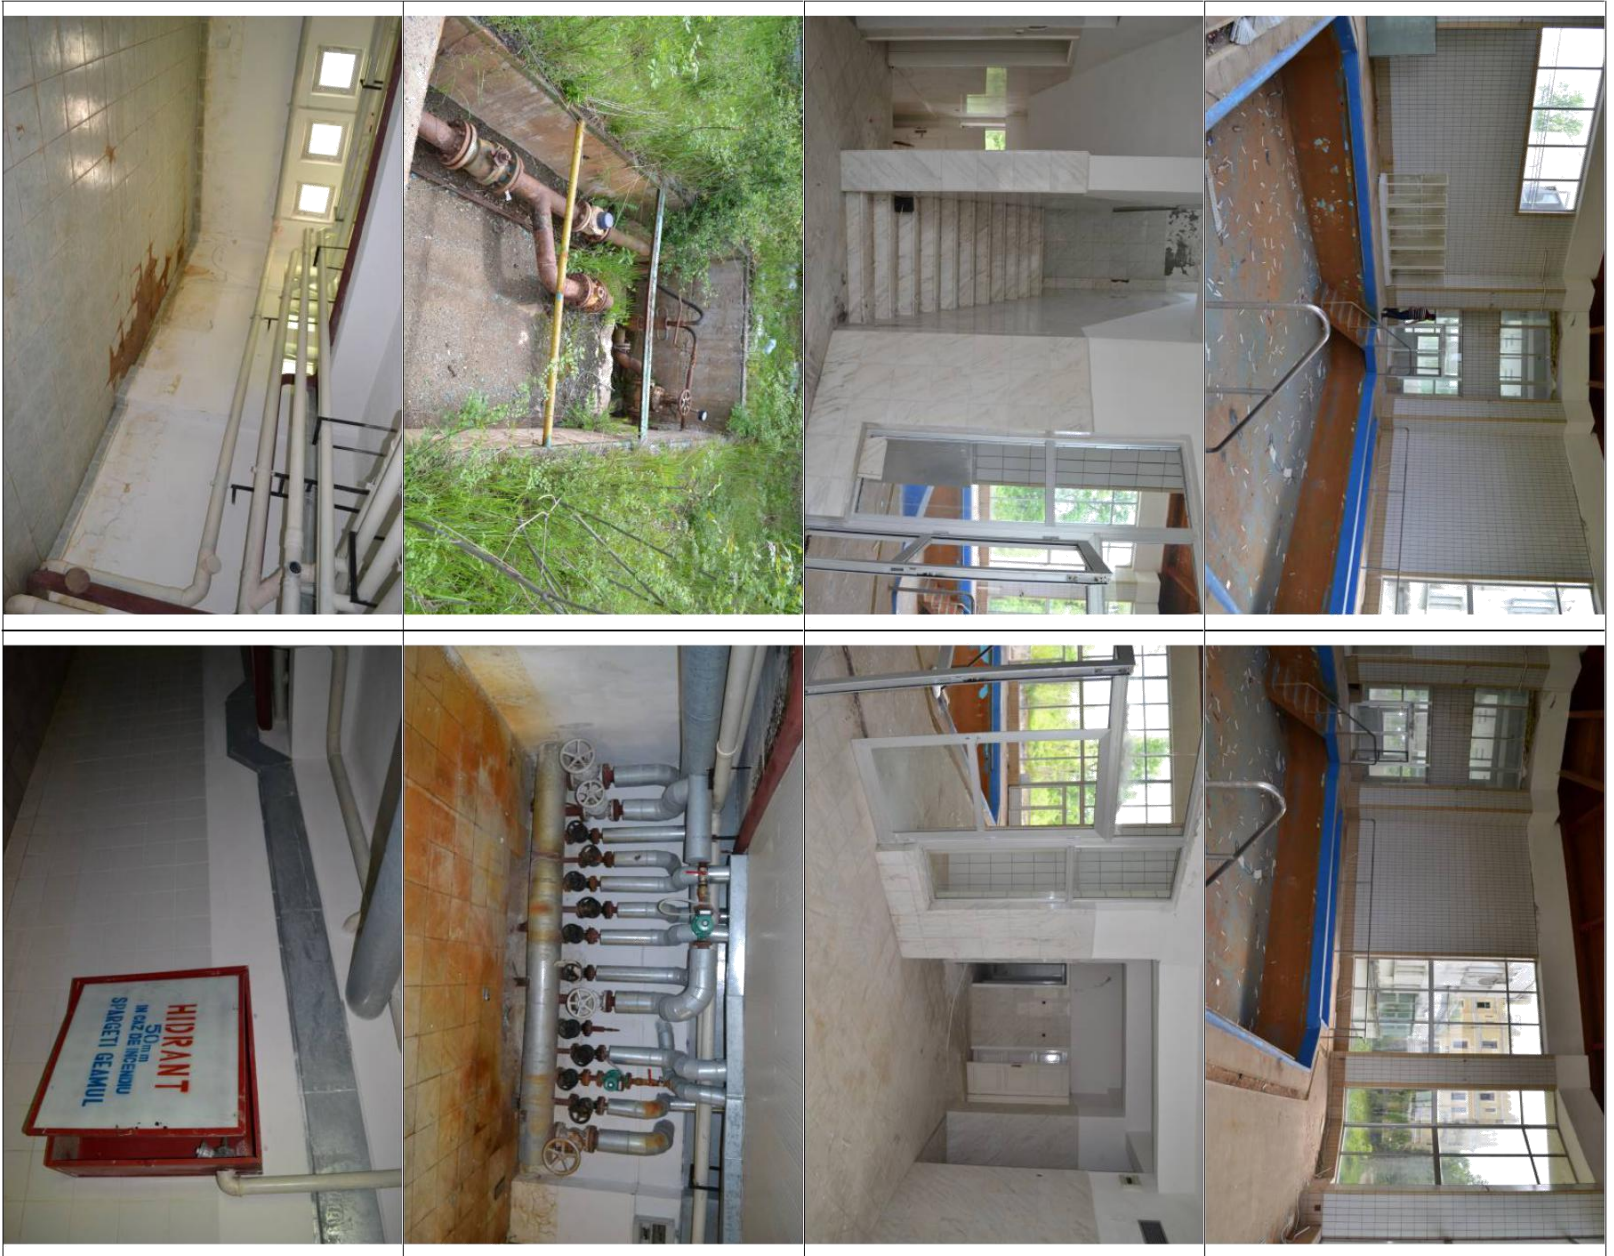
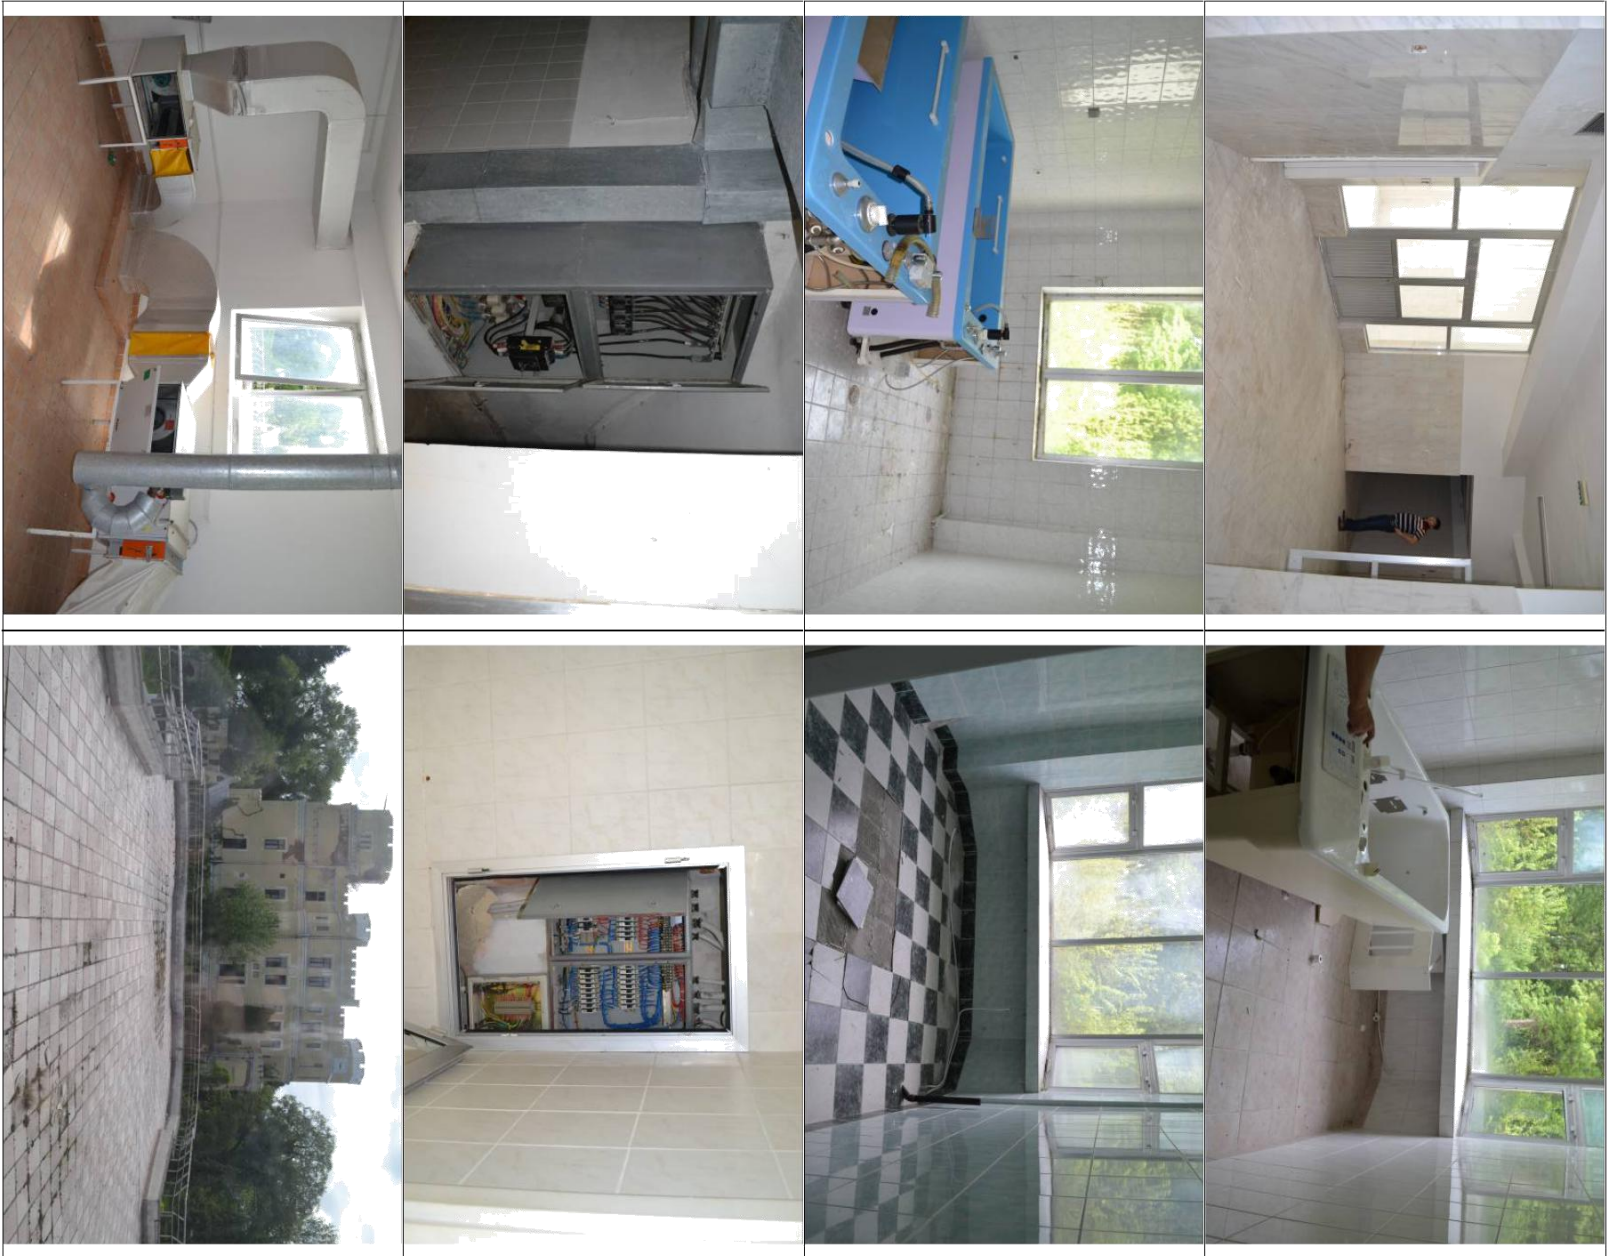
Sheet 5	
Position on the situation plan	C5
Subject	Spa
Owner	S.C. A.D.L. INVEST Ltd.
PIF data	1998/2002
Structural description	
Height level	S+P+1E
Average H	4,3 m
Built area on the ground	934
Unfolded built area	1954
Basis	Reinforced concrete
Structure and partition	Reinforced concrete frames with wall closures of BCA bricks
Floors	Reinforced concrete on the basement and groundfloor
Floor	White marble on the stairway, hallways and partially in the basement; ceramic tiles partially in the basement and in all the groundfloor rooms and rooms upstairs;
Roof	Neat concrete partially in the basement Partially with wooden frame and covering of coated plates in the pool area; Partially the open terrace is paved with ceramic tiles
External finishing	Plastering and whitewashing basis partially covered with granit tiles, Aluminium framing with double glazed windows. Washable paint; marble plating in some rooms and hallways; cermaic tiles on the floors and walls of some rooms and restrooms.

Indoor finishing	The ceiling of the pool room is covered with wooden pannels.
Installations	Wooden indoor framing and aluminium framing with double glazed windows. Power, water and sewage and heating installations disconnected. Ventilation installations. Indoor pool.
Technical conditions	The structure of the building is in good conditions. Partially damaged because of the lack of maintenance. There are parts of the external plastering that are damaged here and there. Indoor finishing damaged on small areas. Local infiltrations.

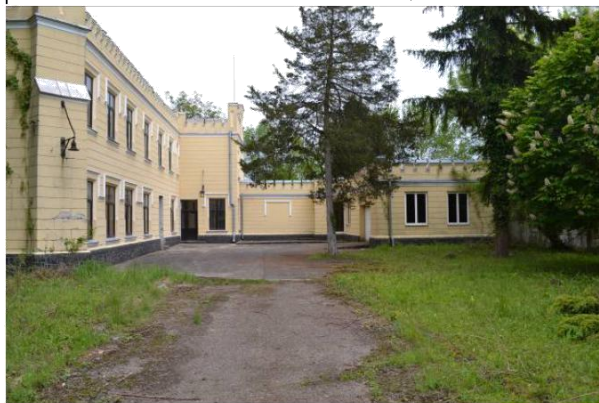
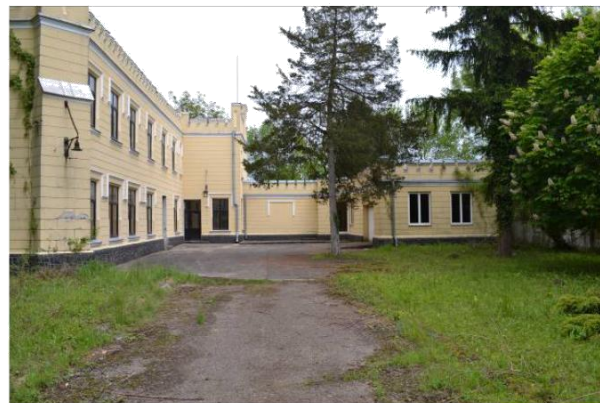
Sheet 6	
Position on the situation pla	C6
Subject	Administrative building
Owner	S.C. A.D.L. INVEST Ltd.
PIF date	2000
Structural description	
Height level	groundfloor
Average H	2,9 m
Area built on the ground	253
Unfolded built area	253
Basis	concrete
Structure and partition	Brick walls
Floors	Reinforced concrete over the groundfloor
Pavements	Ceramic tiles and mosaic in the hallways, restrooms and kitchen, laminated flooring in the rooms
Roof	Type water insulation terrace
External finishing	Plastering imitating reliefs, separations and margins, plain whitewashing
Indoor finishing	Basis of apparent stone, PVC external framing with double glazed windows Washable paint; in some rooms, decorative paint type decocquartz, ceramic wall tiles in the kitchen and restrooms, suspended ceiling plates of poliurethan pannels in some rooms, wooden indoor framing.
Installations	Power, water and sewage and heating installations disconnected

Technical conditions	The structure of the building is in good conditions. partially damaged because of the lack of maintenance.  There are some portions of damaged plastering ng damaged on small areas. Local Infiltrations.
