**Nr.: 36/09.05.2017**

## **Evaluation report**

**„Degenfeld-Schomburg” Castle Balc Facility , Bihor county, Romania.**

**Date:**  
**May 2017**

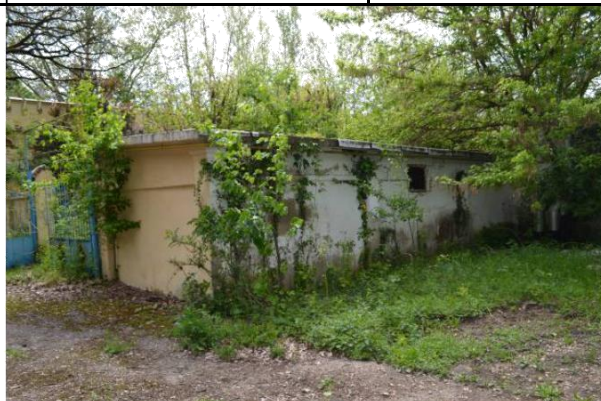
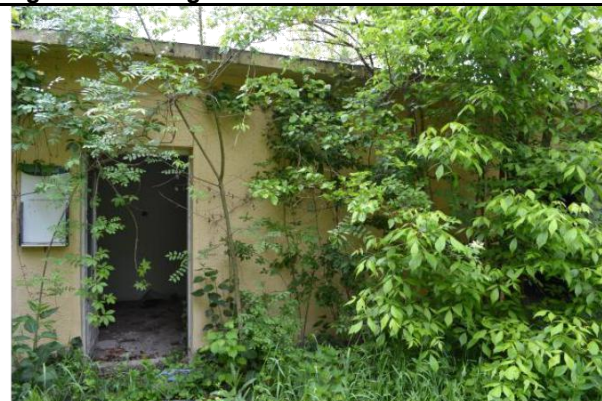
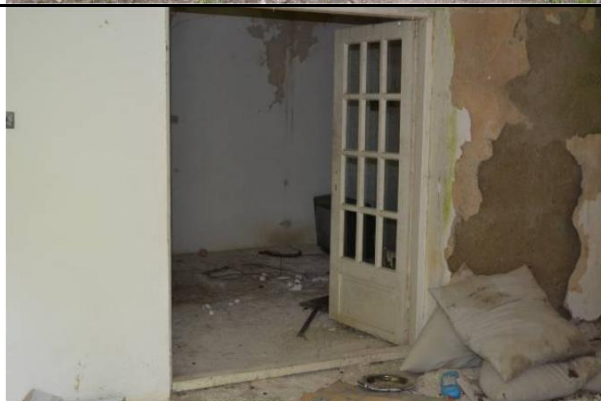
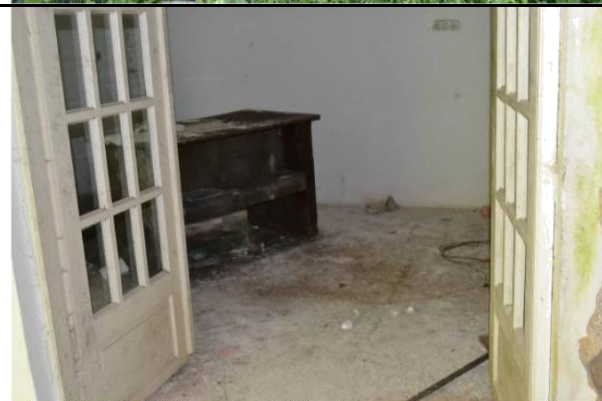
Sheet 7	
Position on the situation plan	C7
Subject	Laundry drying room
Owner	S.C. A.D.L. INVEST Ltd.
PIF date	1968
Structural description	
Height level	Groundfloor
Average h	2,5 m
Built area on the ground	142
Unfolded built area	142
Basis	Concrete
Structure and partition	Brick walls
Floors	Reinforced concrete over groundfloor
Pavement	Concrete
Roof	Type waterproof insulation terrace
External finishing	Sprayed plastering and plain whitewashing, wooden framing
Indoor finishing	Plain plastering and whitewashing, ceramic wall tiles on the contour for one room, wooden framing
Installations	Power, water and sewage and heating, gas installations disconnected
Technical conditions	The structure of the building is in good condition. damaged beacuse of the lack of maintenance.  Disfunctional and disconnected installations. The external area is overgrown with vegetation.

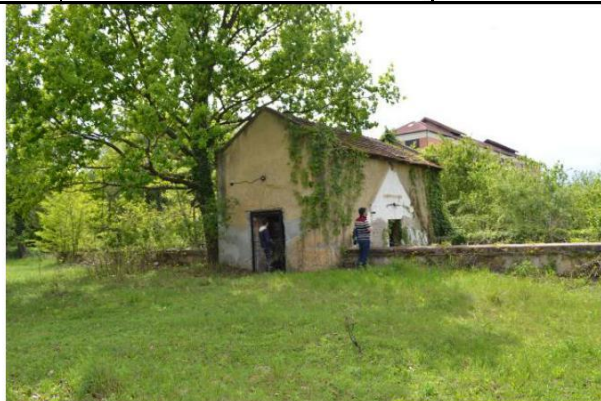
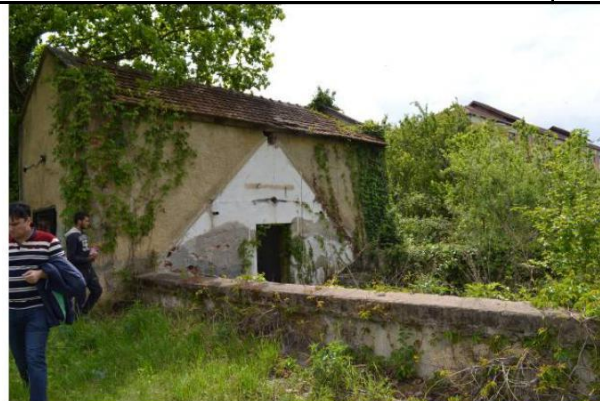
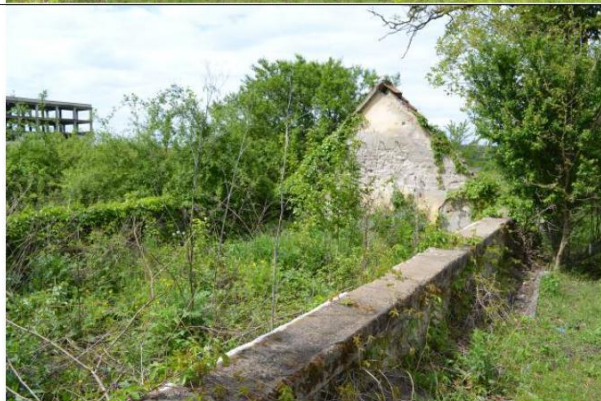
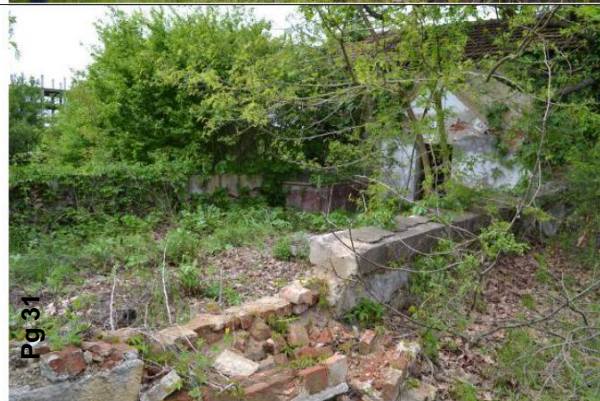
<b>Position in the situation plan</b>	<b>C10</b>
<b>Subject</b>	<b>Greenhouse</b>
<b>Owner</b>	<b>S.C. A.D.L. INVEST Ltd.</b>
<b>PIF Data</b>	<b>1890</b>
<b>Structuraldescription</b>	<b>Half earthed structure with the structure on brick wall basis, metallic structure and glass pannels.</b>
<b>Height levele</b>	<b>P</b>
<b>Average h</b>	<b>3,5 m</b>
<b>Built area on the ground</b>	<b>204</b>
<b>Unfolded built area</b>	<b>204</b>
<b>Basis</b>	<b>Brick structure</b>
<b>Structure and partition</b>	<b>Brick wall structure 1 meter high and metallic structure for glass pannels</b>
<b>Floor</b>	-
<b>Pavement</b>	-
<b>Roof</b>	<b>Glass pannels</b>
<b>External finishing</b>	-
<b>Indoor finishing</b>	-
<b>Installations</b>	<b>Power, water and sewage, heating installations disconnected</b>
<b>Technical condition</b>	<b>The greenhouse is no longer functional. Only the central building walls are standing while the basis is deserted .</b>

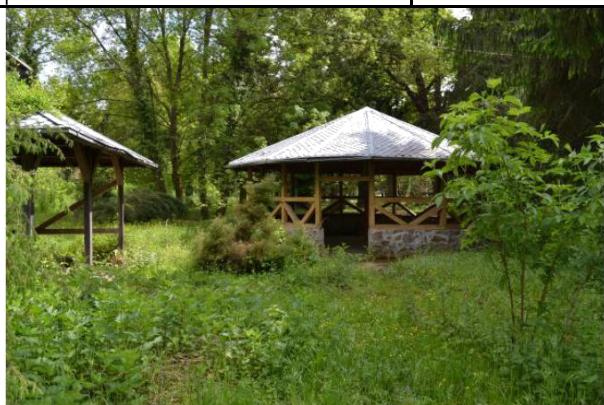
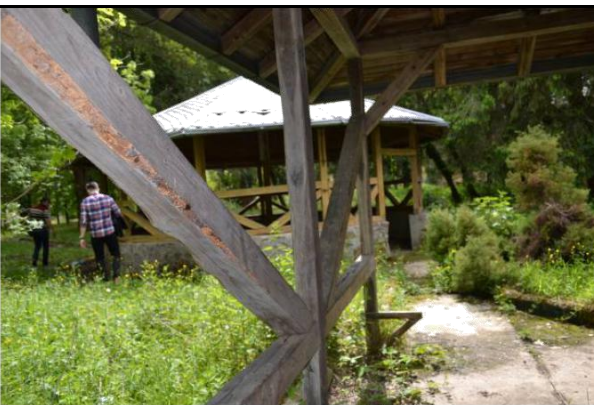
<b>Sheet 15</b>	
<b>Position on the situation plan</b>	<b>C15</b>
<b>Subject</b>	<b>Terrace</b>
<b>Owner</b>	<b>S.C. A.D.L. INVEST Ltd.</b>
<b>PIF Data</b>	<b>-</b>
<b>Structural description</b>	<b>Kiosk type structure on stone basis, wooden beam structure Roof with scale type cover</b>

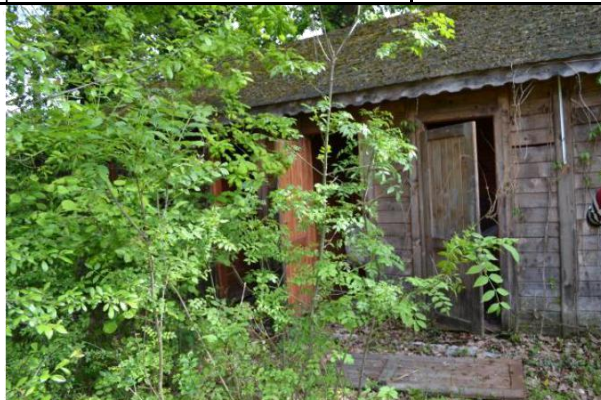
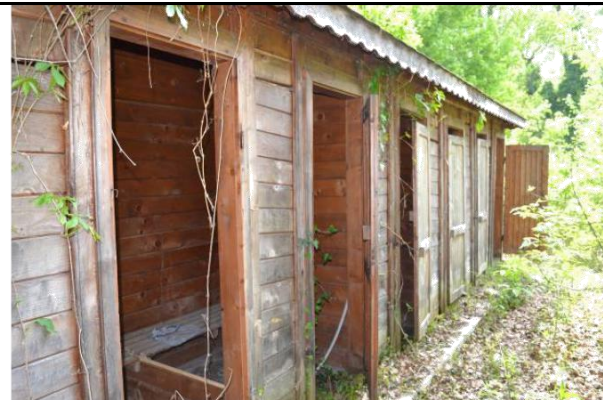
<b>Sheet 16</b>	
<b>Position on the situation plan</b>	<b>C16</b>
<b>Subject</b>	<b>Wooden cottage</b>
<b>Owner</b>	<b>S.C. A.D.L. INVEST Ltd.</b>
<b>PIF Data</b>	<b>-</b>
<b>Structural description</b>	<b>Wooden structure. Changing lockers for the pool</b>
<b>Structure condition</b>	<b>Degraded. Lack of maintenance</b>

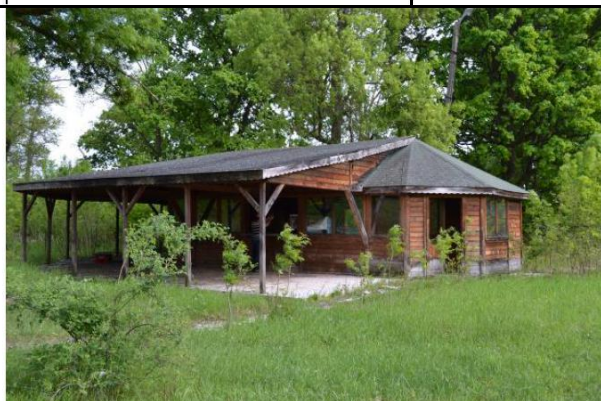
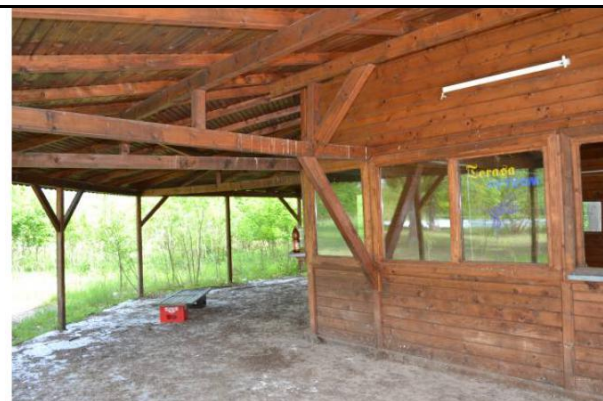
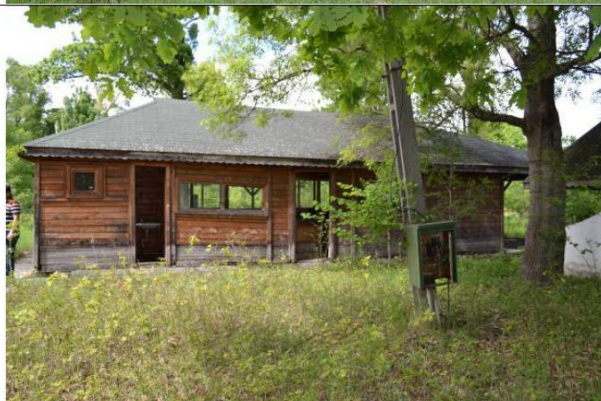
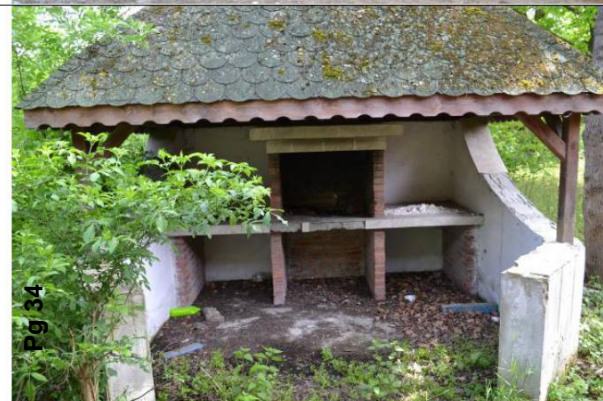
<b>Sheet 17</b>	
<b>Position on the situation plan</b>	<b>C17</b>
<b>Subject</b>	<b>Wooden cottage</b>
<b>Owner</b>	<b>S.C. A.D.L. INVEST Ltd.</b>
<b>PIF Data</b>	<b>-</b>
<b>Structural description</b>	<b>Bar type wooden structure and terrace nearby the pool</b>
<b>Condition</b>	<b>Degraded. Lack of maintenance</b>

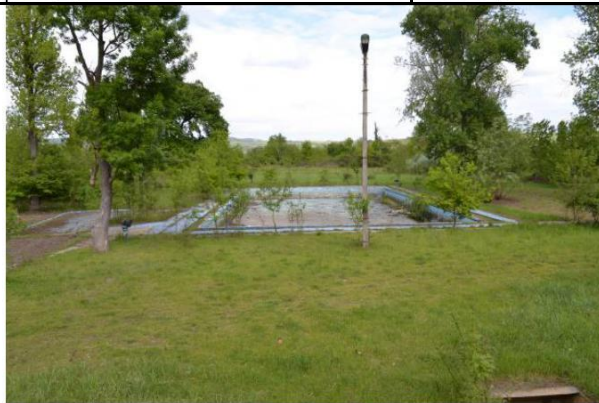
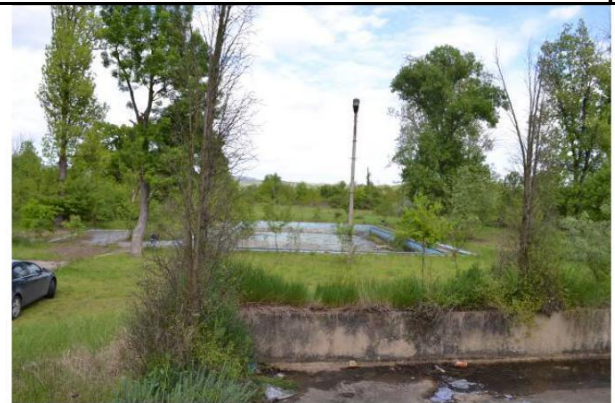
<b>Sheet 19</b>	
<b>Position on the situation plan</b>	<b>C19</b>
<b>Subject</b>	<b>Pool</b>
<b>Owner</b>	<b>S.C. A.D.L. INVEST Ltd.</b>
<b>PIF Data</b>	<b>1968</b>
<b>Structural description</b>	<b>Reinforced concrete</b>
<b>Condition</b>	<b>Lack of maintenance</b>

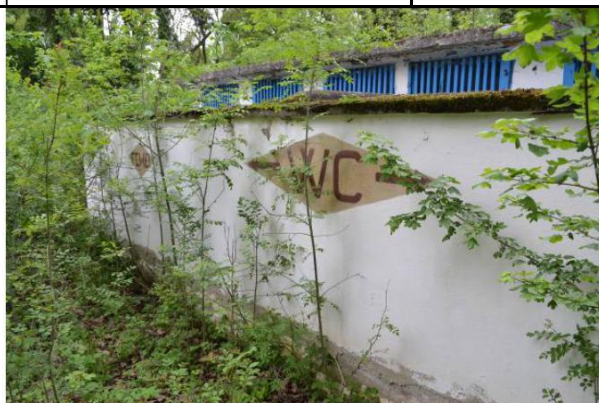
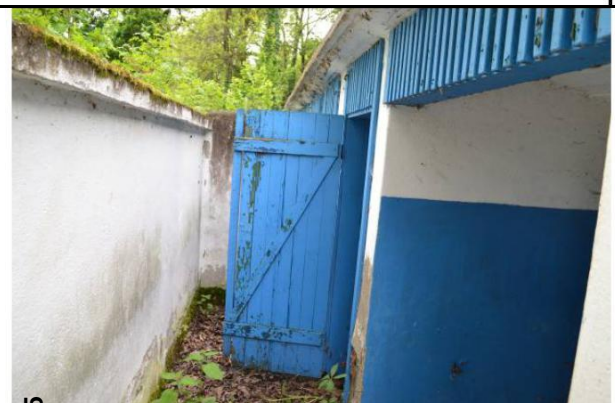
<b>Sheet 20</b>	
<b>Position on the situation plan</b>	<b>C20</b>
<b>Subject</b>	<b>Restroom</b>
<b>Owner</b>	<b>S.C. A.D.L. INVEST Ltd.</b>
<b>PIF Data</b>	<b>1968</b>
<b>Structural description</b>	<b>Concrete basis, brick walls</b>
<b>Building condition</b>	<b>Lack of maintenance. Vegetation overgrown</b>

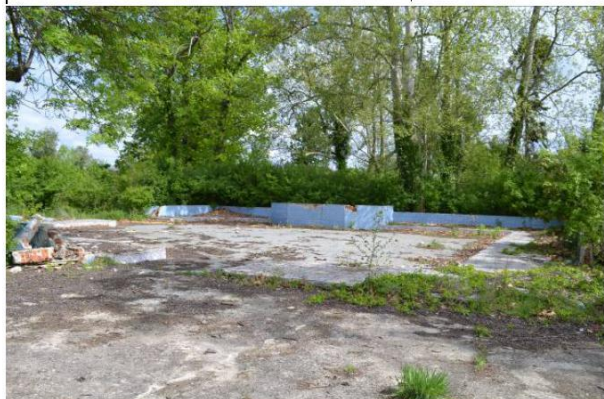
<b>Sheet 26</b>	
<b>Position on the situation plan</b>	<b>C26</b>
<b>Subject</b>	<b>Dance club</b>
<b>Owner</b>	<b>S.C. A.D.L. INVEST Ltd.</b>
<b>PIF Data</b>	<b>1968</b>
<b>Structural description</b>	<b>Open yard made of concrete and concrete layer.</b>
<b>Condition</b>	<b>Ruin</b>

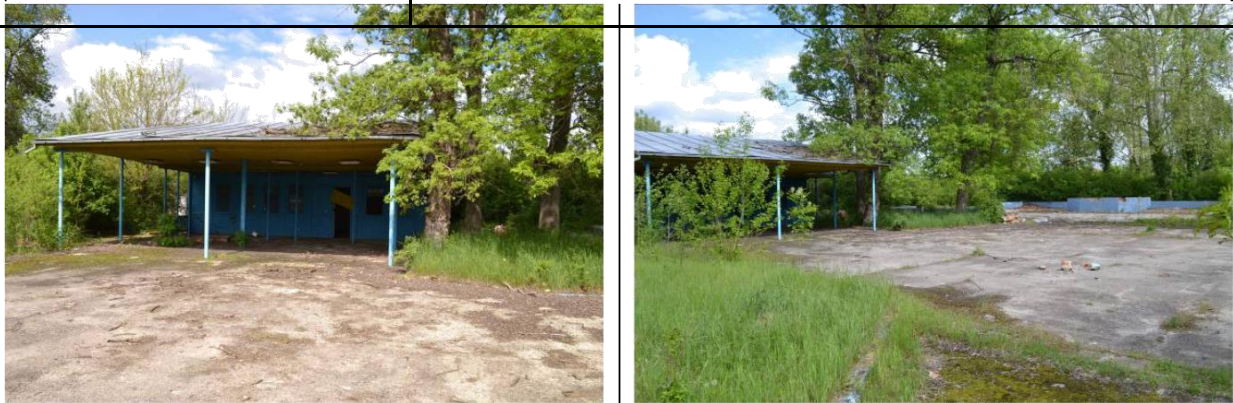
<b>Sheet 27</b>	
<b>Position on the situation plan</b>	<b>C27</b>
<b>Subject</b>	<b>Locker</b>
<b>Owner</b>	<b>S.C. A.D.L. INVEST Ltd.</b>
<b>PIF Date</b>	<b>-</b>
<b>Structural description</b>	<b>No data available</b>
<b>Building condition</b>	<b>Demolished</b>
<b>Sheet 28</b>	
<b>Position on the situation plan</b>	<b>C28</b>
<b>Subject</b>	<b>Wooden locker</b>
<b>Owner</b>	<b>S.C. A.D.L. INVEST Ltd.</b>
<b>PIF Date</b>	<b>-</b>
<b>Structural description</b>	<b>No data available</b>
<b>Building condition</b>	<b>Demolished</b>
<b>Sheet 29</b>	
<b>Position on the situation plan</b>	<b>C29</b>
<b>Subject</b>	<b>Terrace</b>
<b>Owner</b>	<b>S.C. A.D.L. INVEST Ltd.</b>
<b>PIF Date</b>	<b>1968</b>
<b>Structural description</b>	<b>Building with a metallic structure with partial wooden closing and galvanized tin roof.</b>
<b>Building condition</b>	<b>Old structure, lacking maintenance. Condition – not satisfactory</b>
